# Allied-Axis

THE PHOTO JOURNAL OF THE SECOND WORLD WAR

# Contents

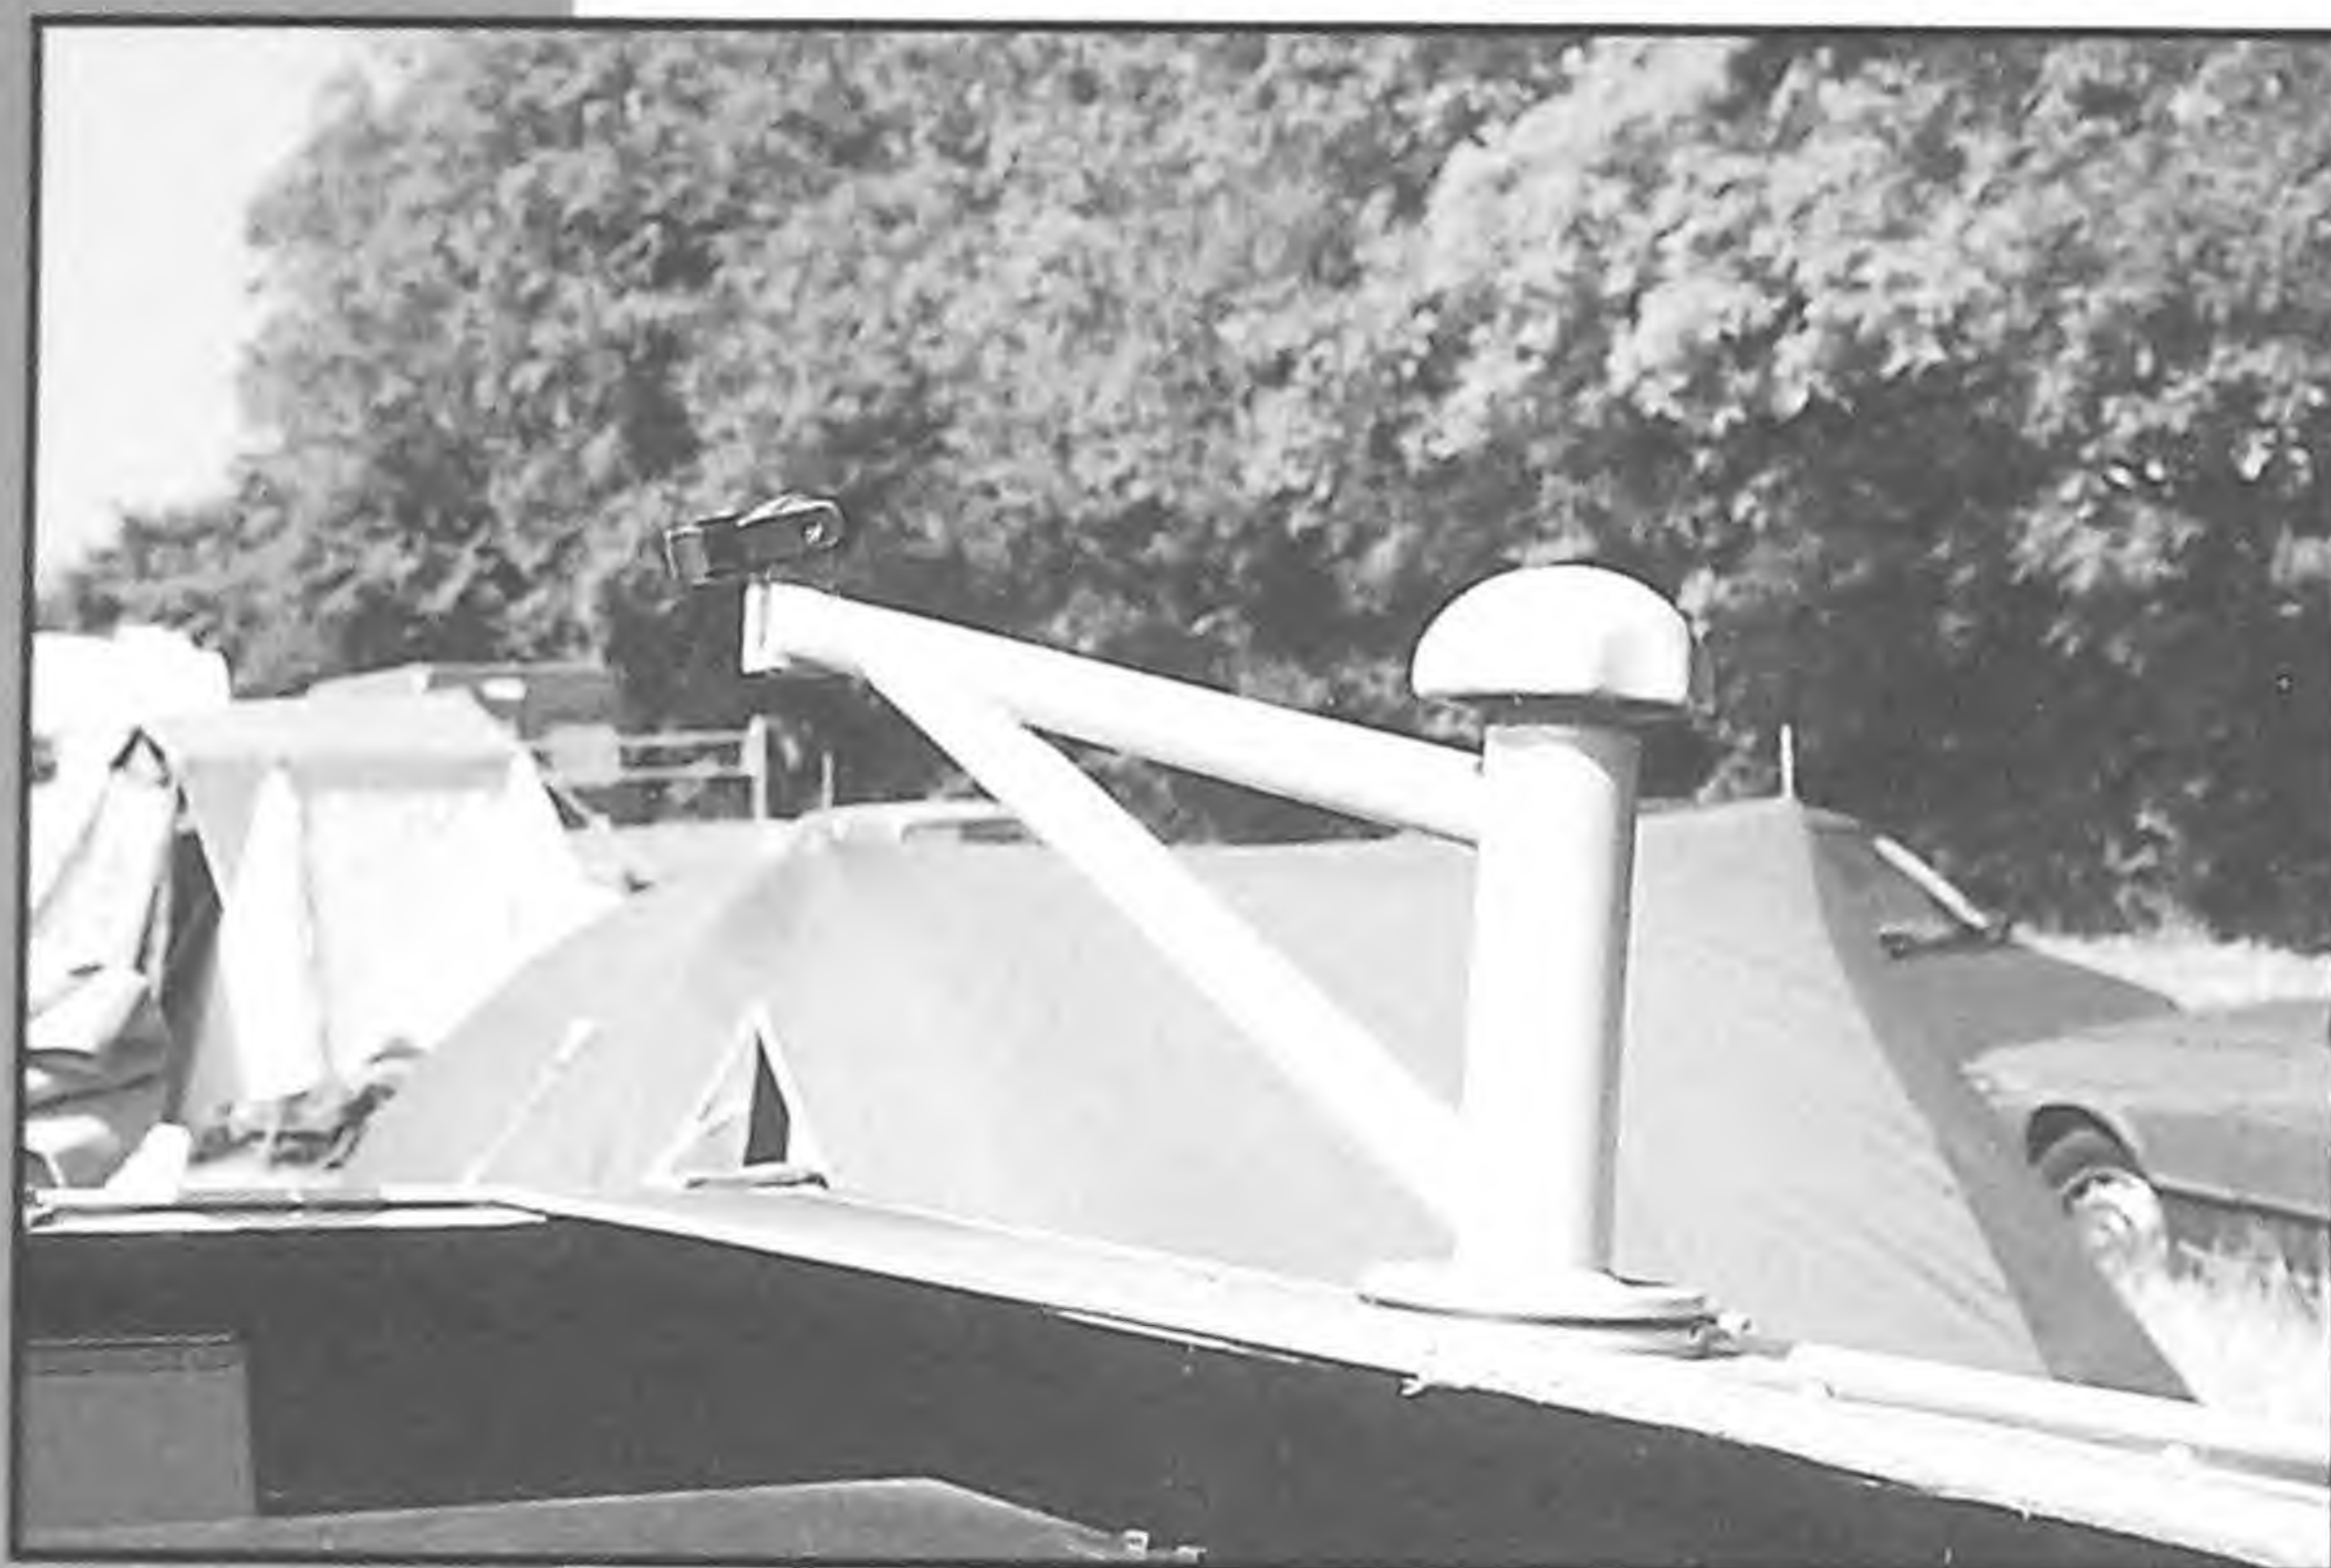
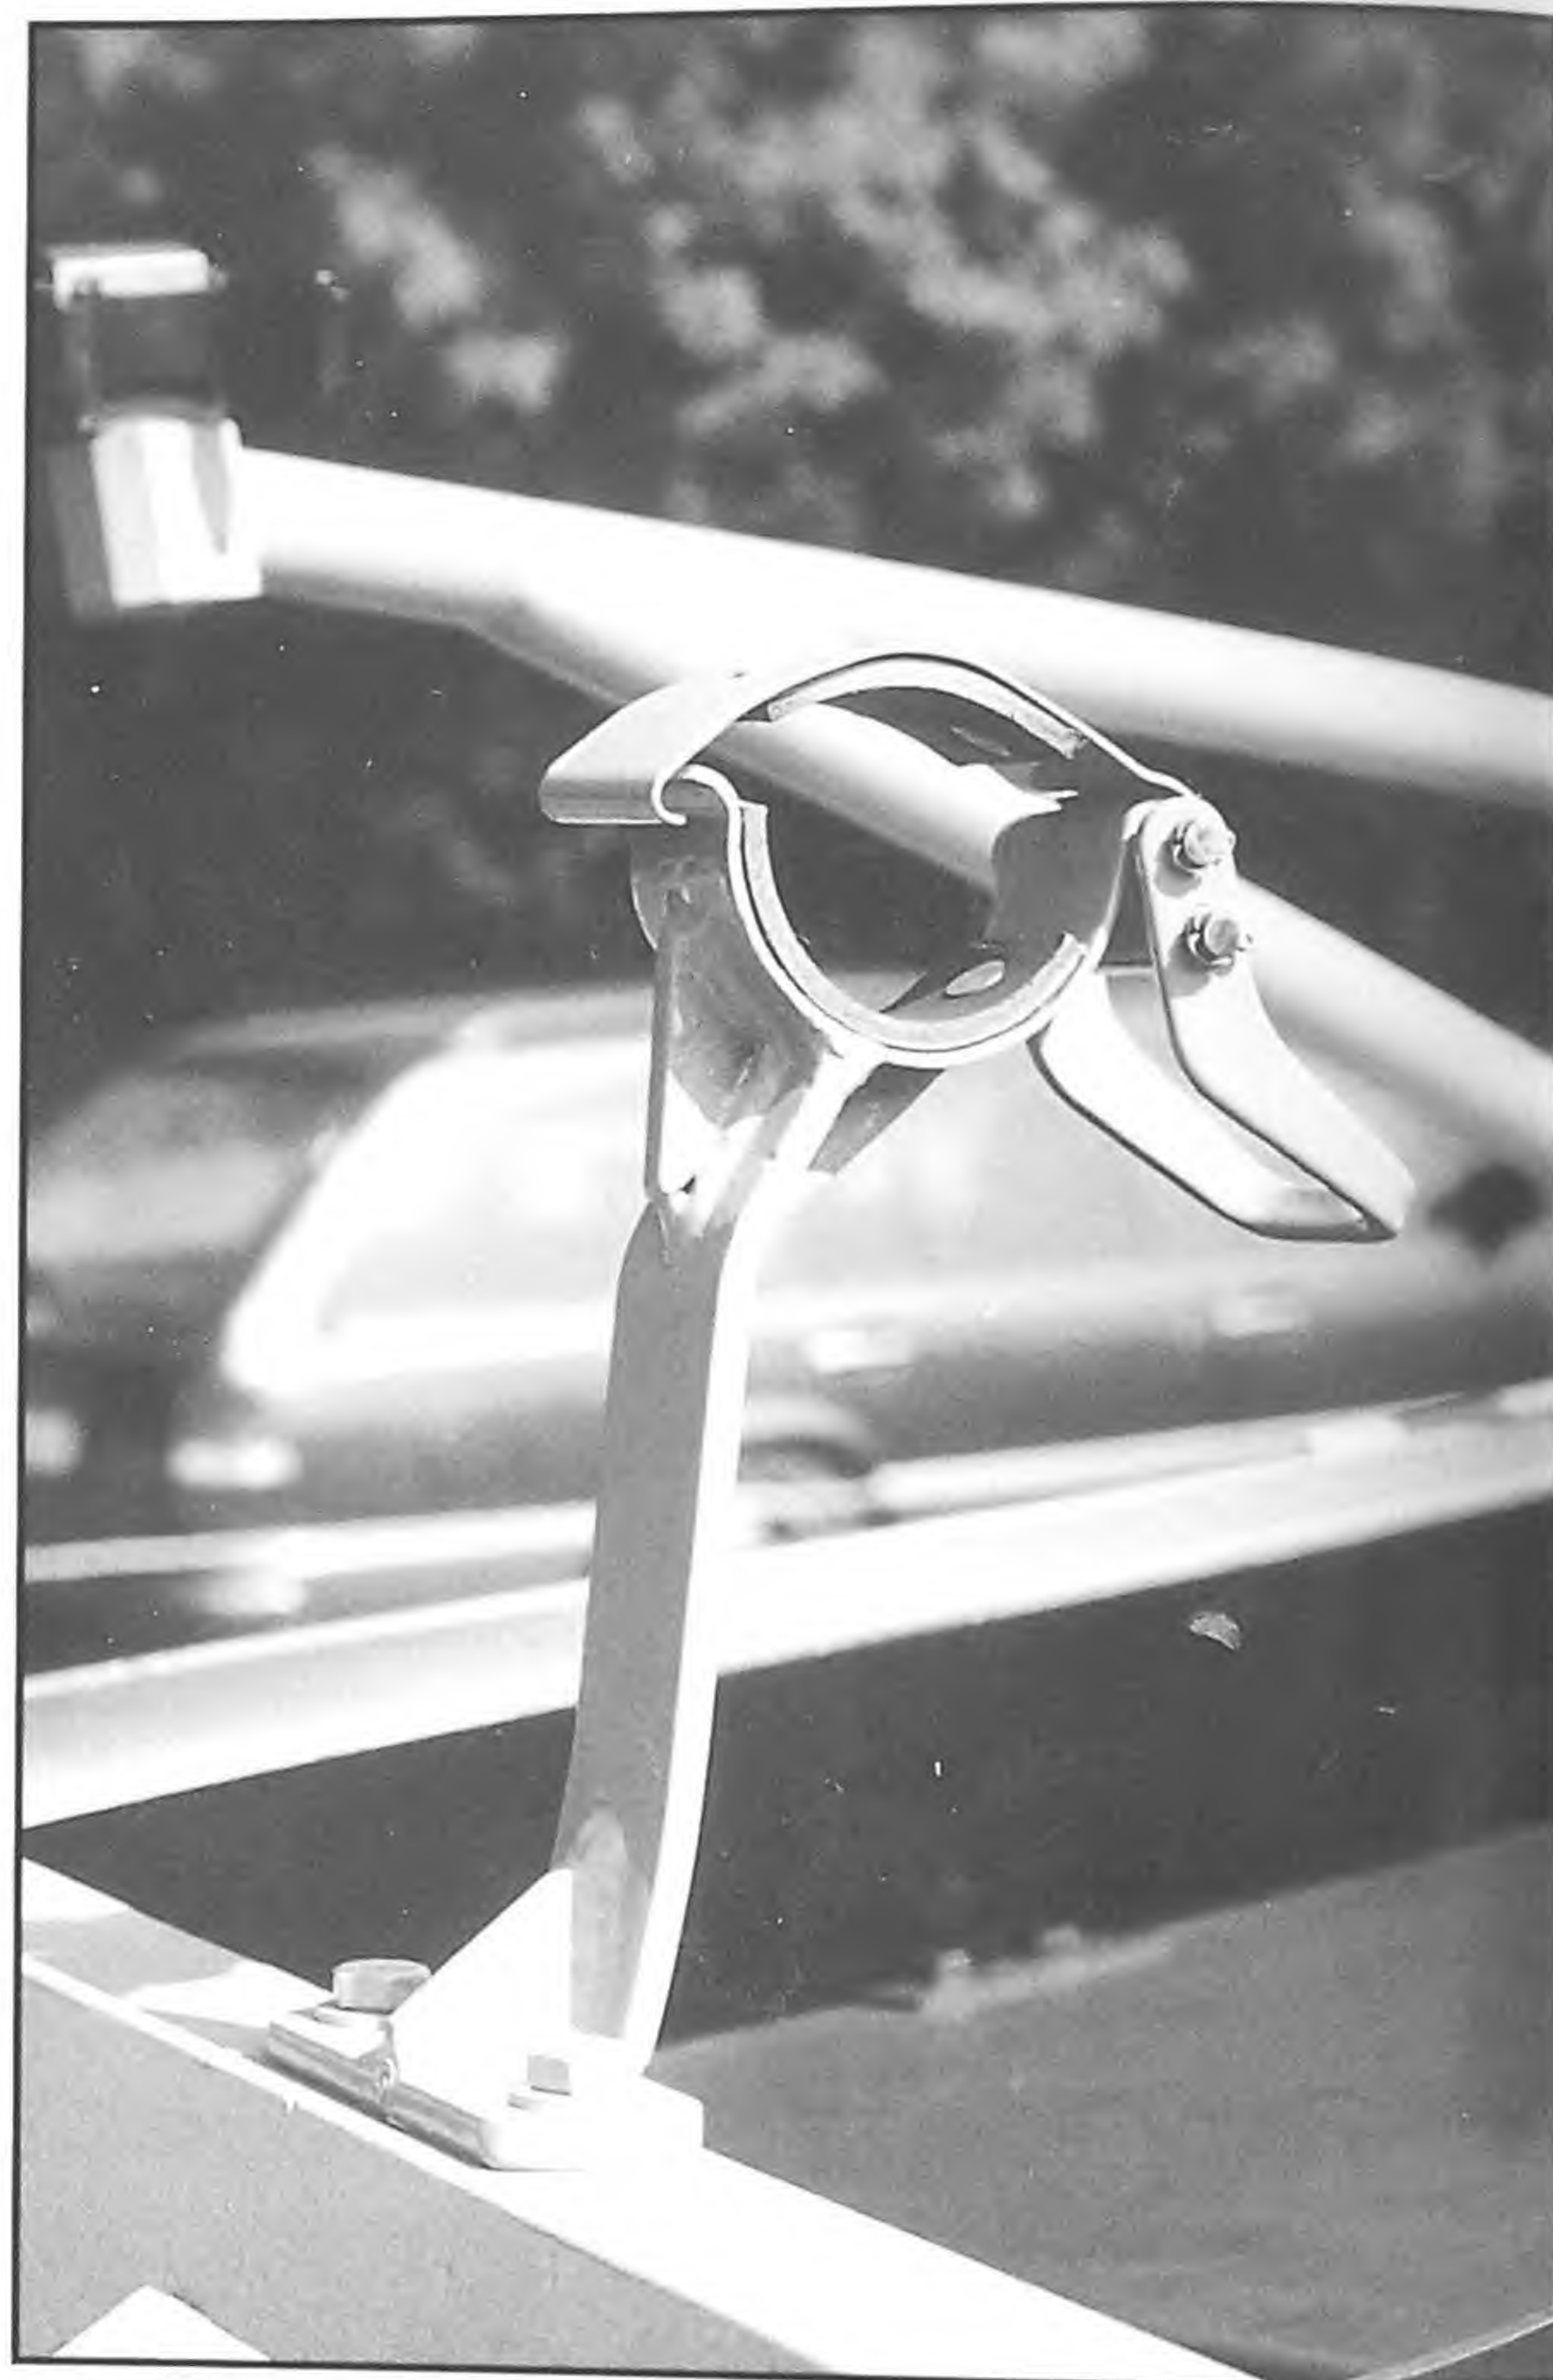
**Top left:** Another of the tarp tie-downs located around the top of the hull. **Above left:** This is the rear mounted MG rail. The two MG mounts denote a 250/1 (s MG), which carried the second, support half of the "Halbgruppe." **Above right:** This very interesting late detail is the travel lock for the rear mounted MG. It is installed on the top of the right rear superstructure.

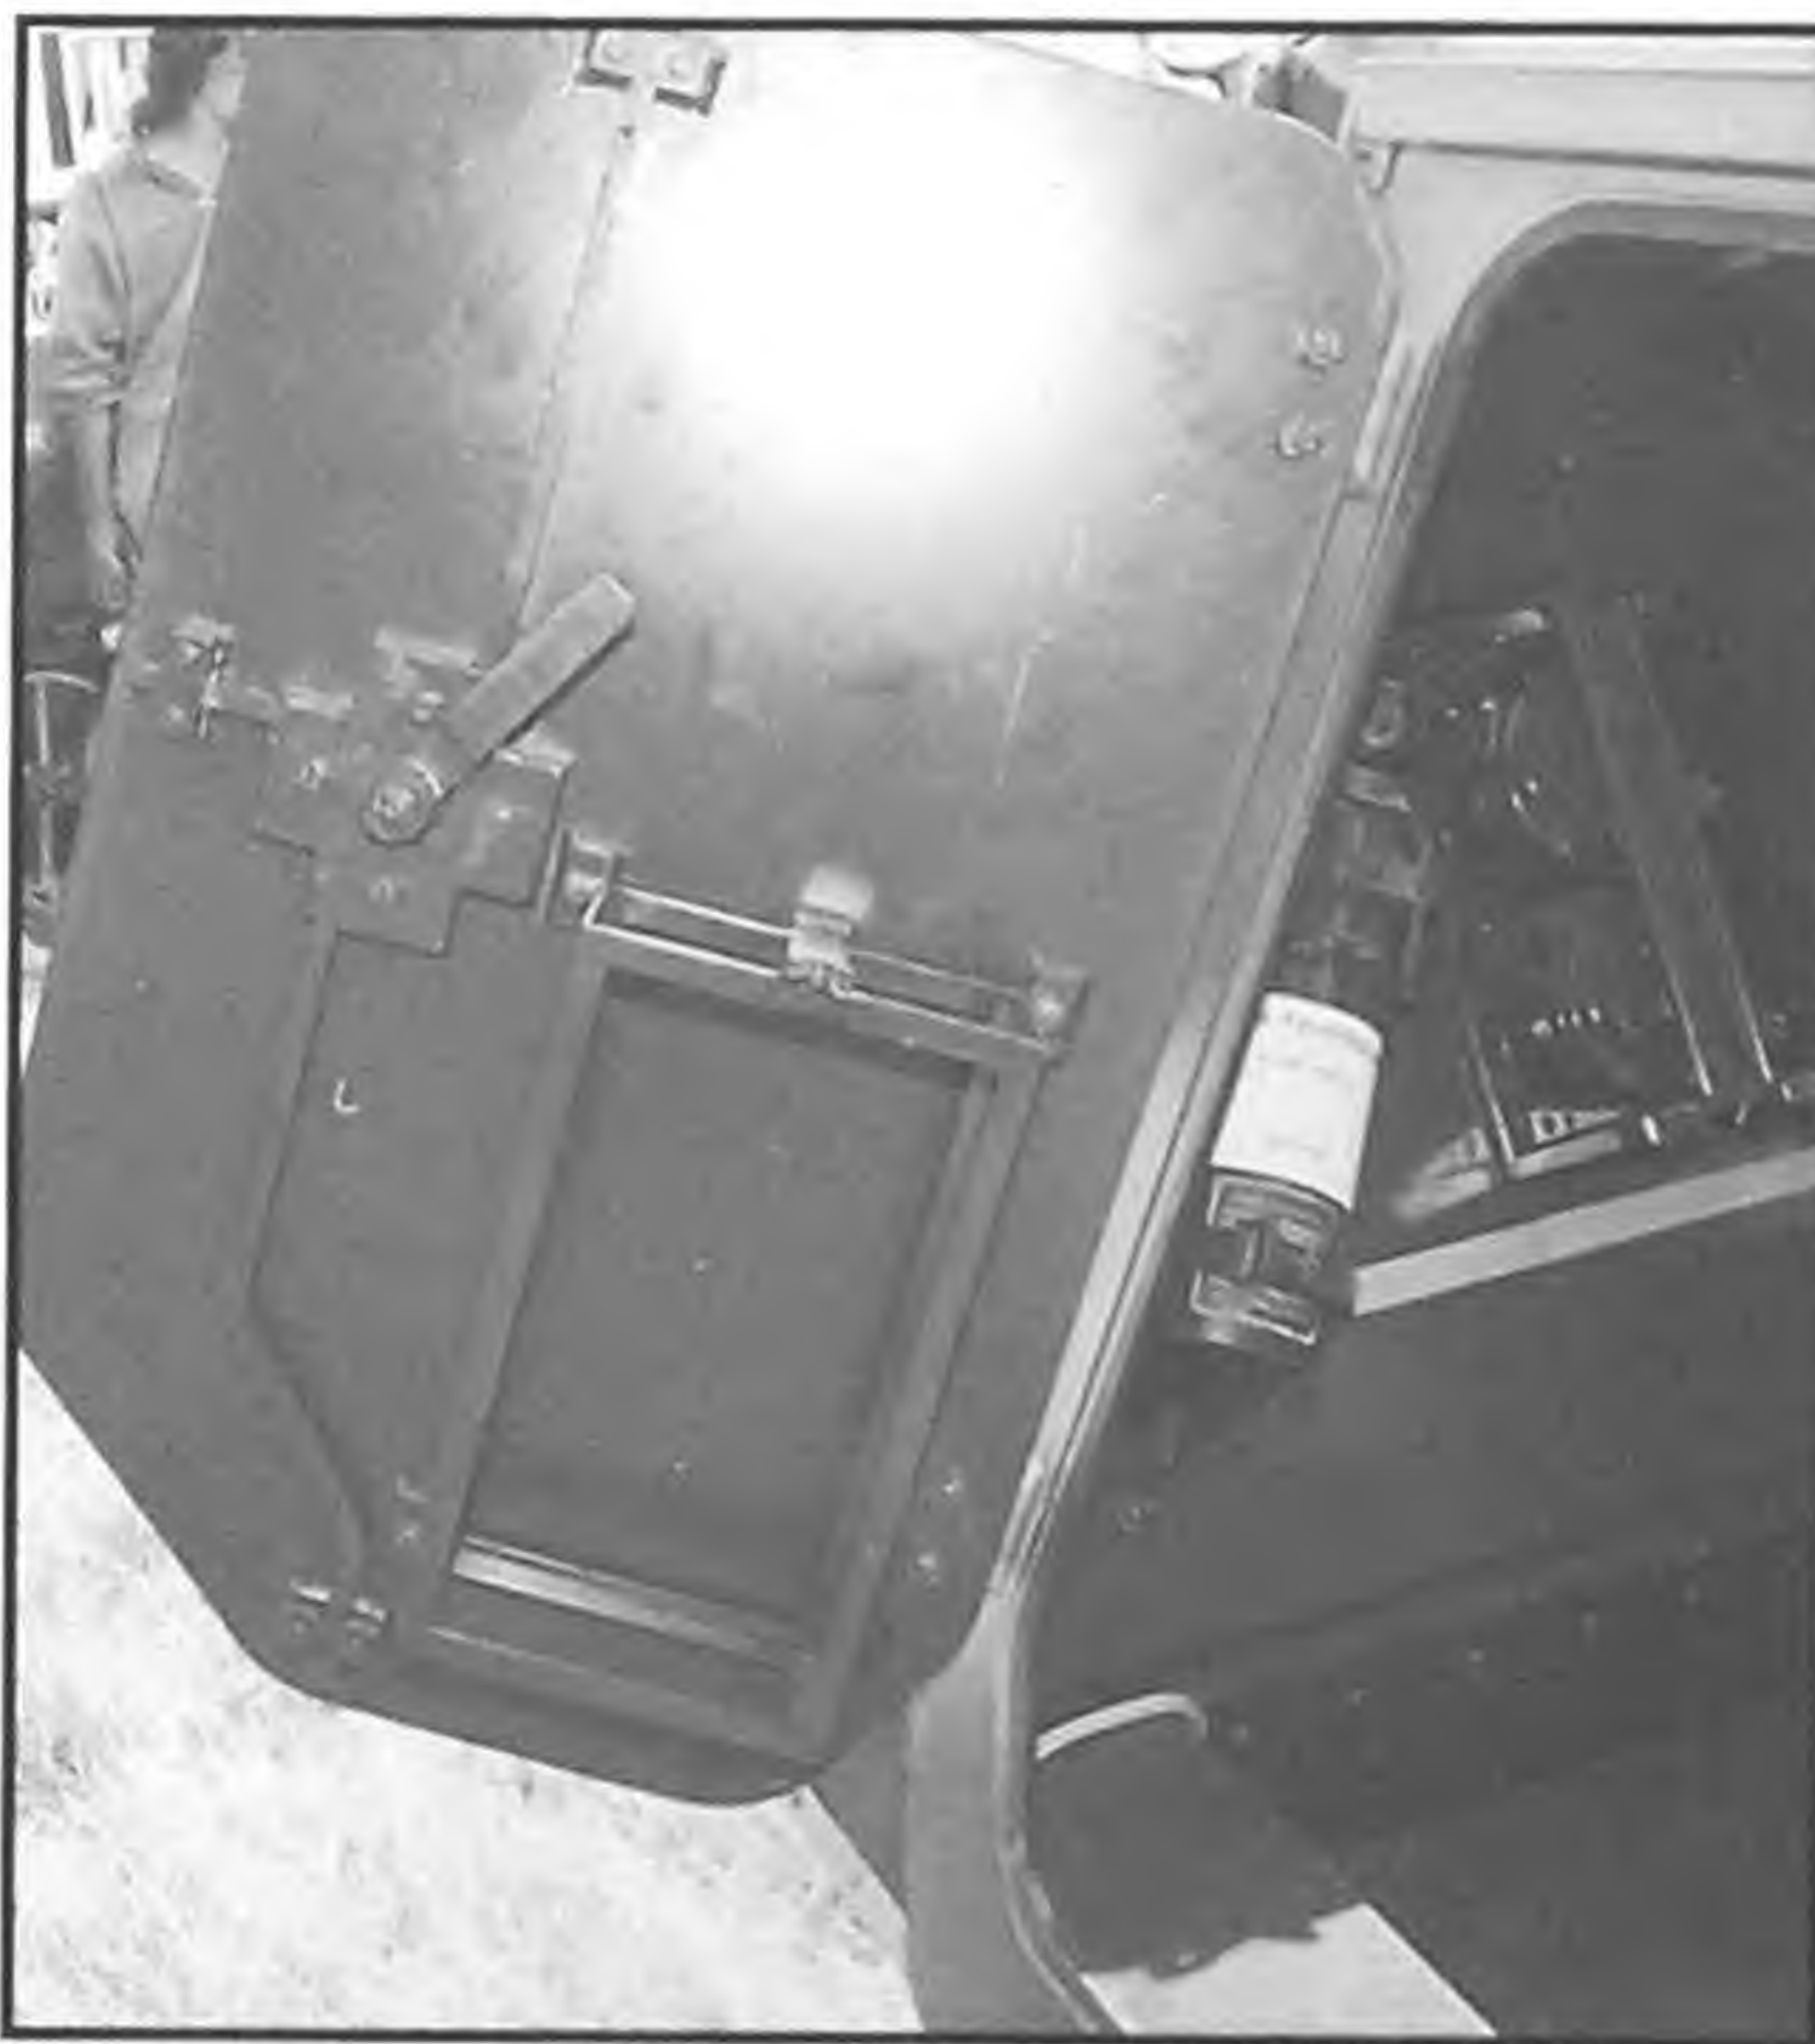
**Top left:** Both the front wheels were fabricated from light armored steel. The design was the common military split rim style. The air valve stem is seen at the left edge of the photo. **Top right:** A detail shot of the front drive sprocket. The teeth of the sprocket each contained a small wheel that moved as the tracks passed over it. **Above left:** The detail of the sprocket face, including the interior bolts and the casting numbers. **Above right:** The interior of the rear door. The empty bracket was for the installation of the first aid kit.

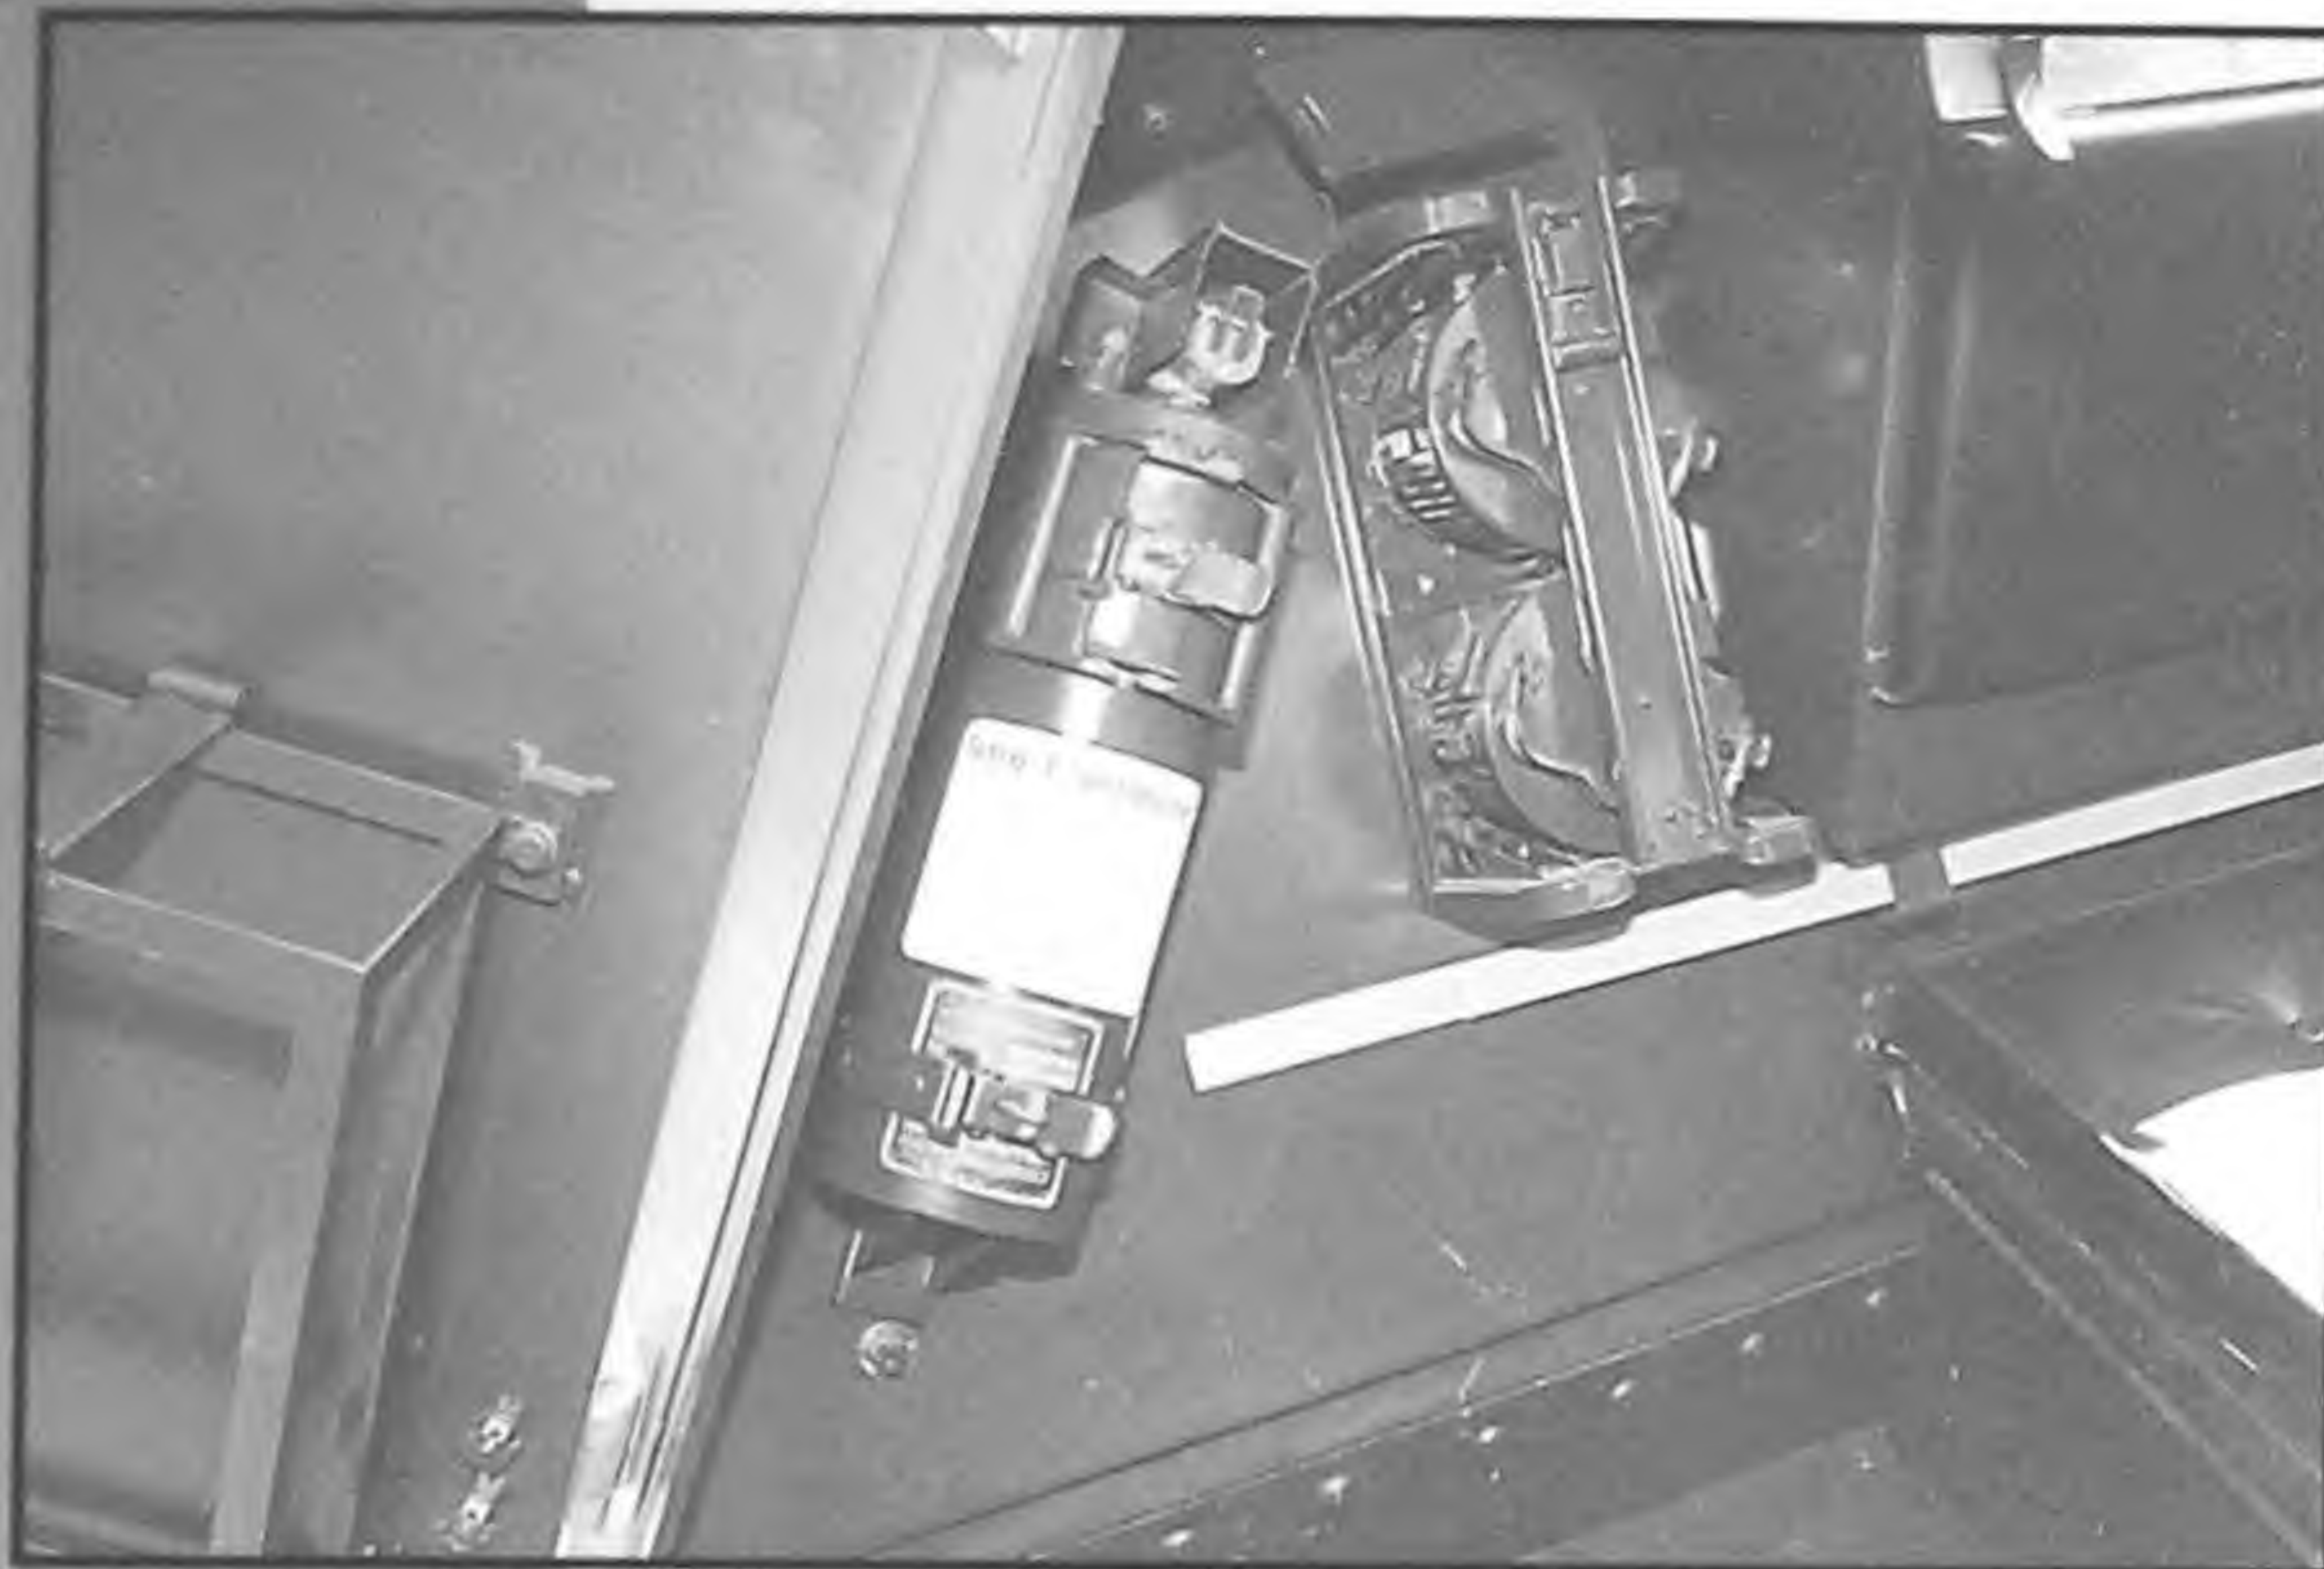
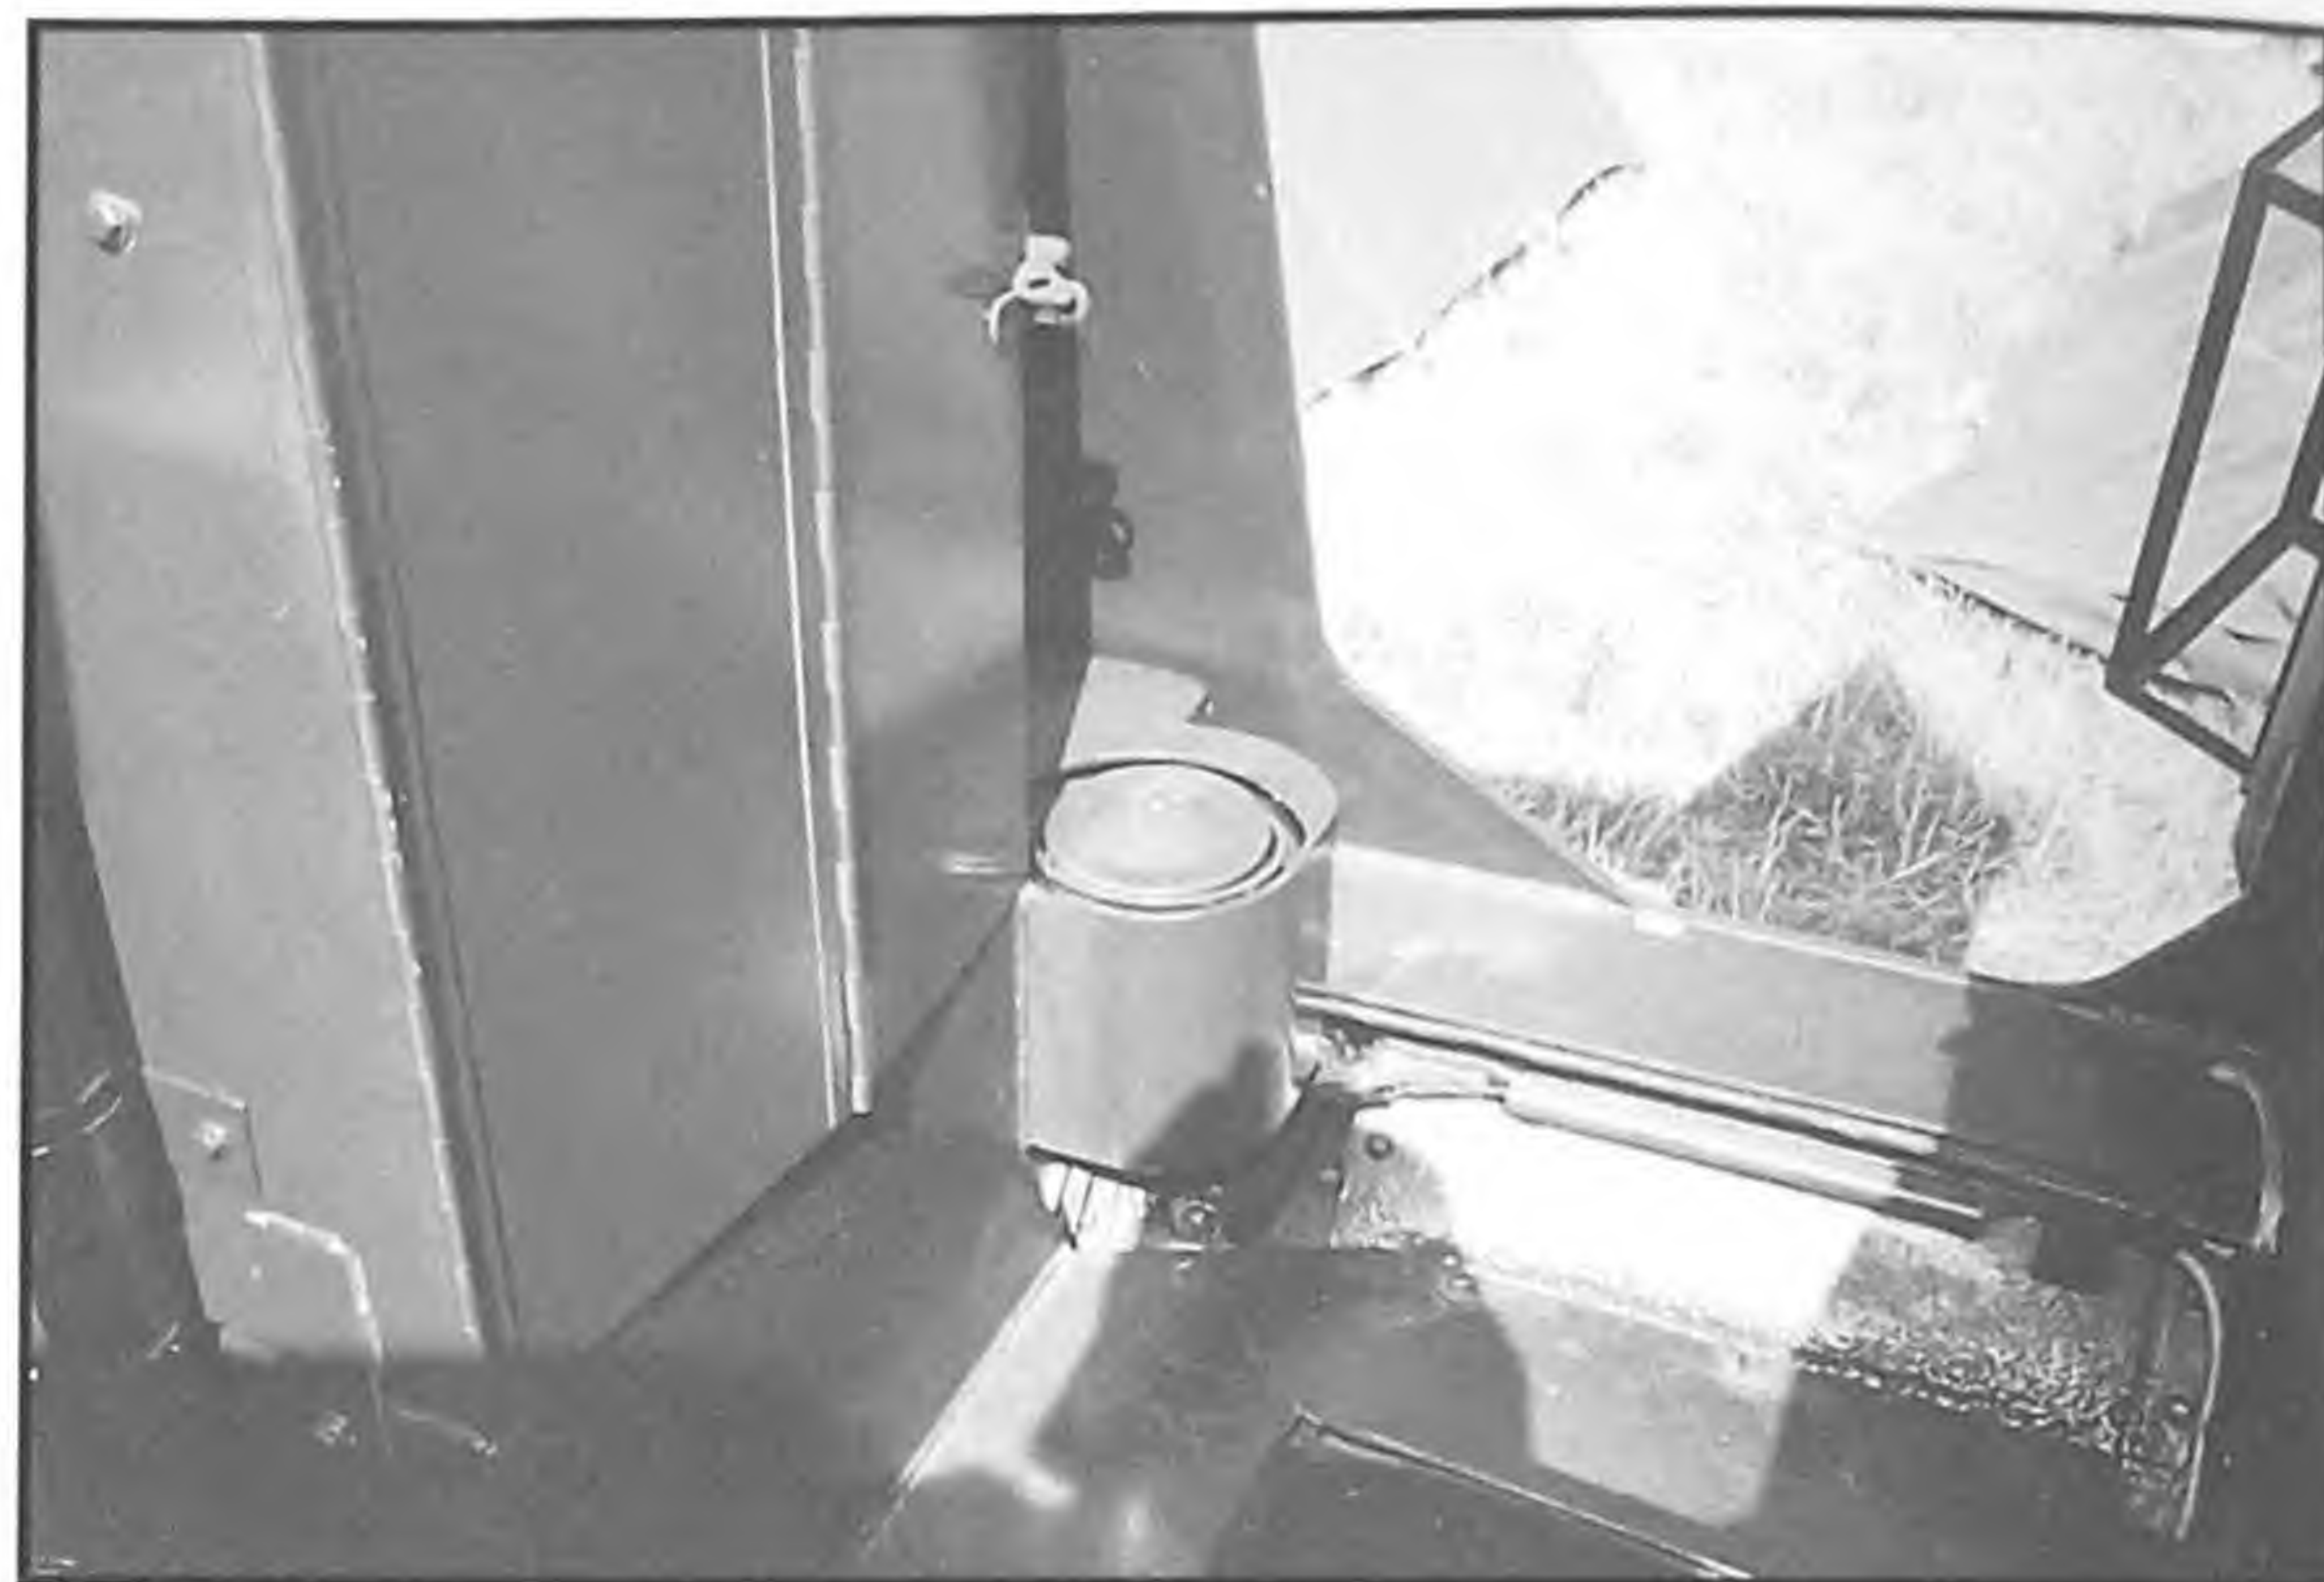
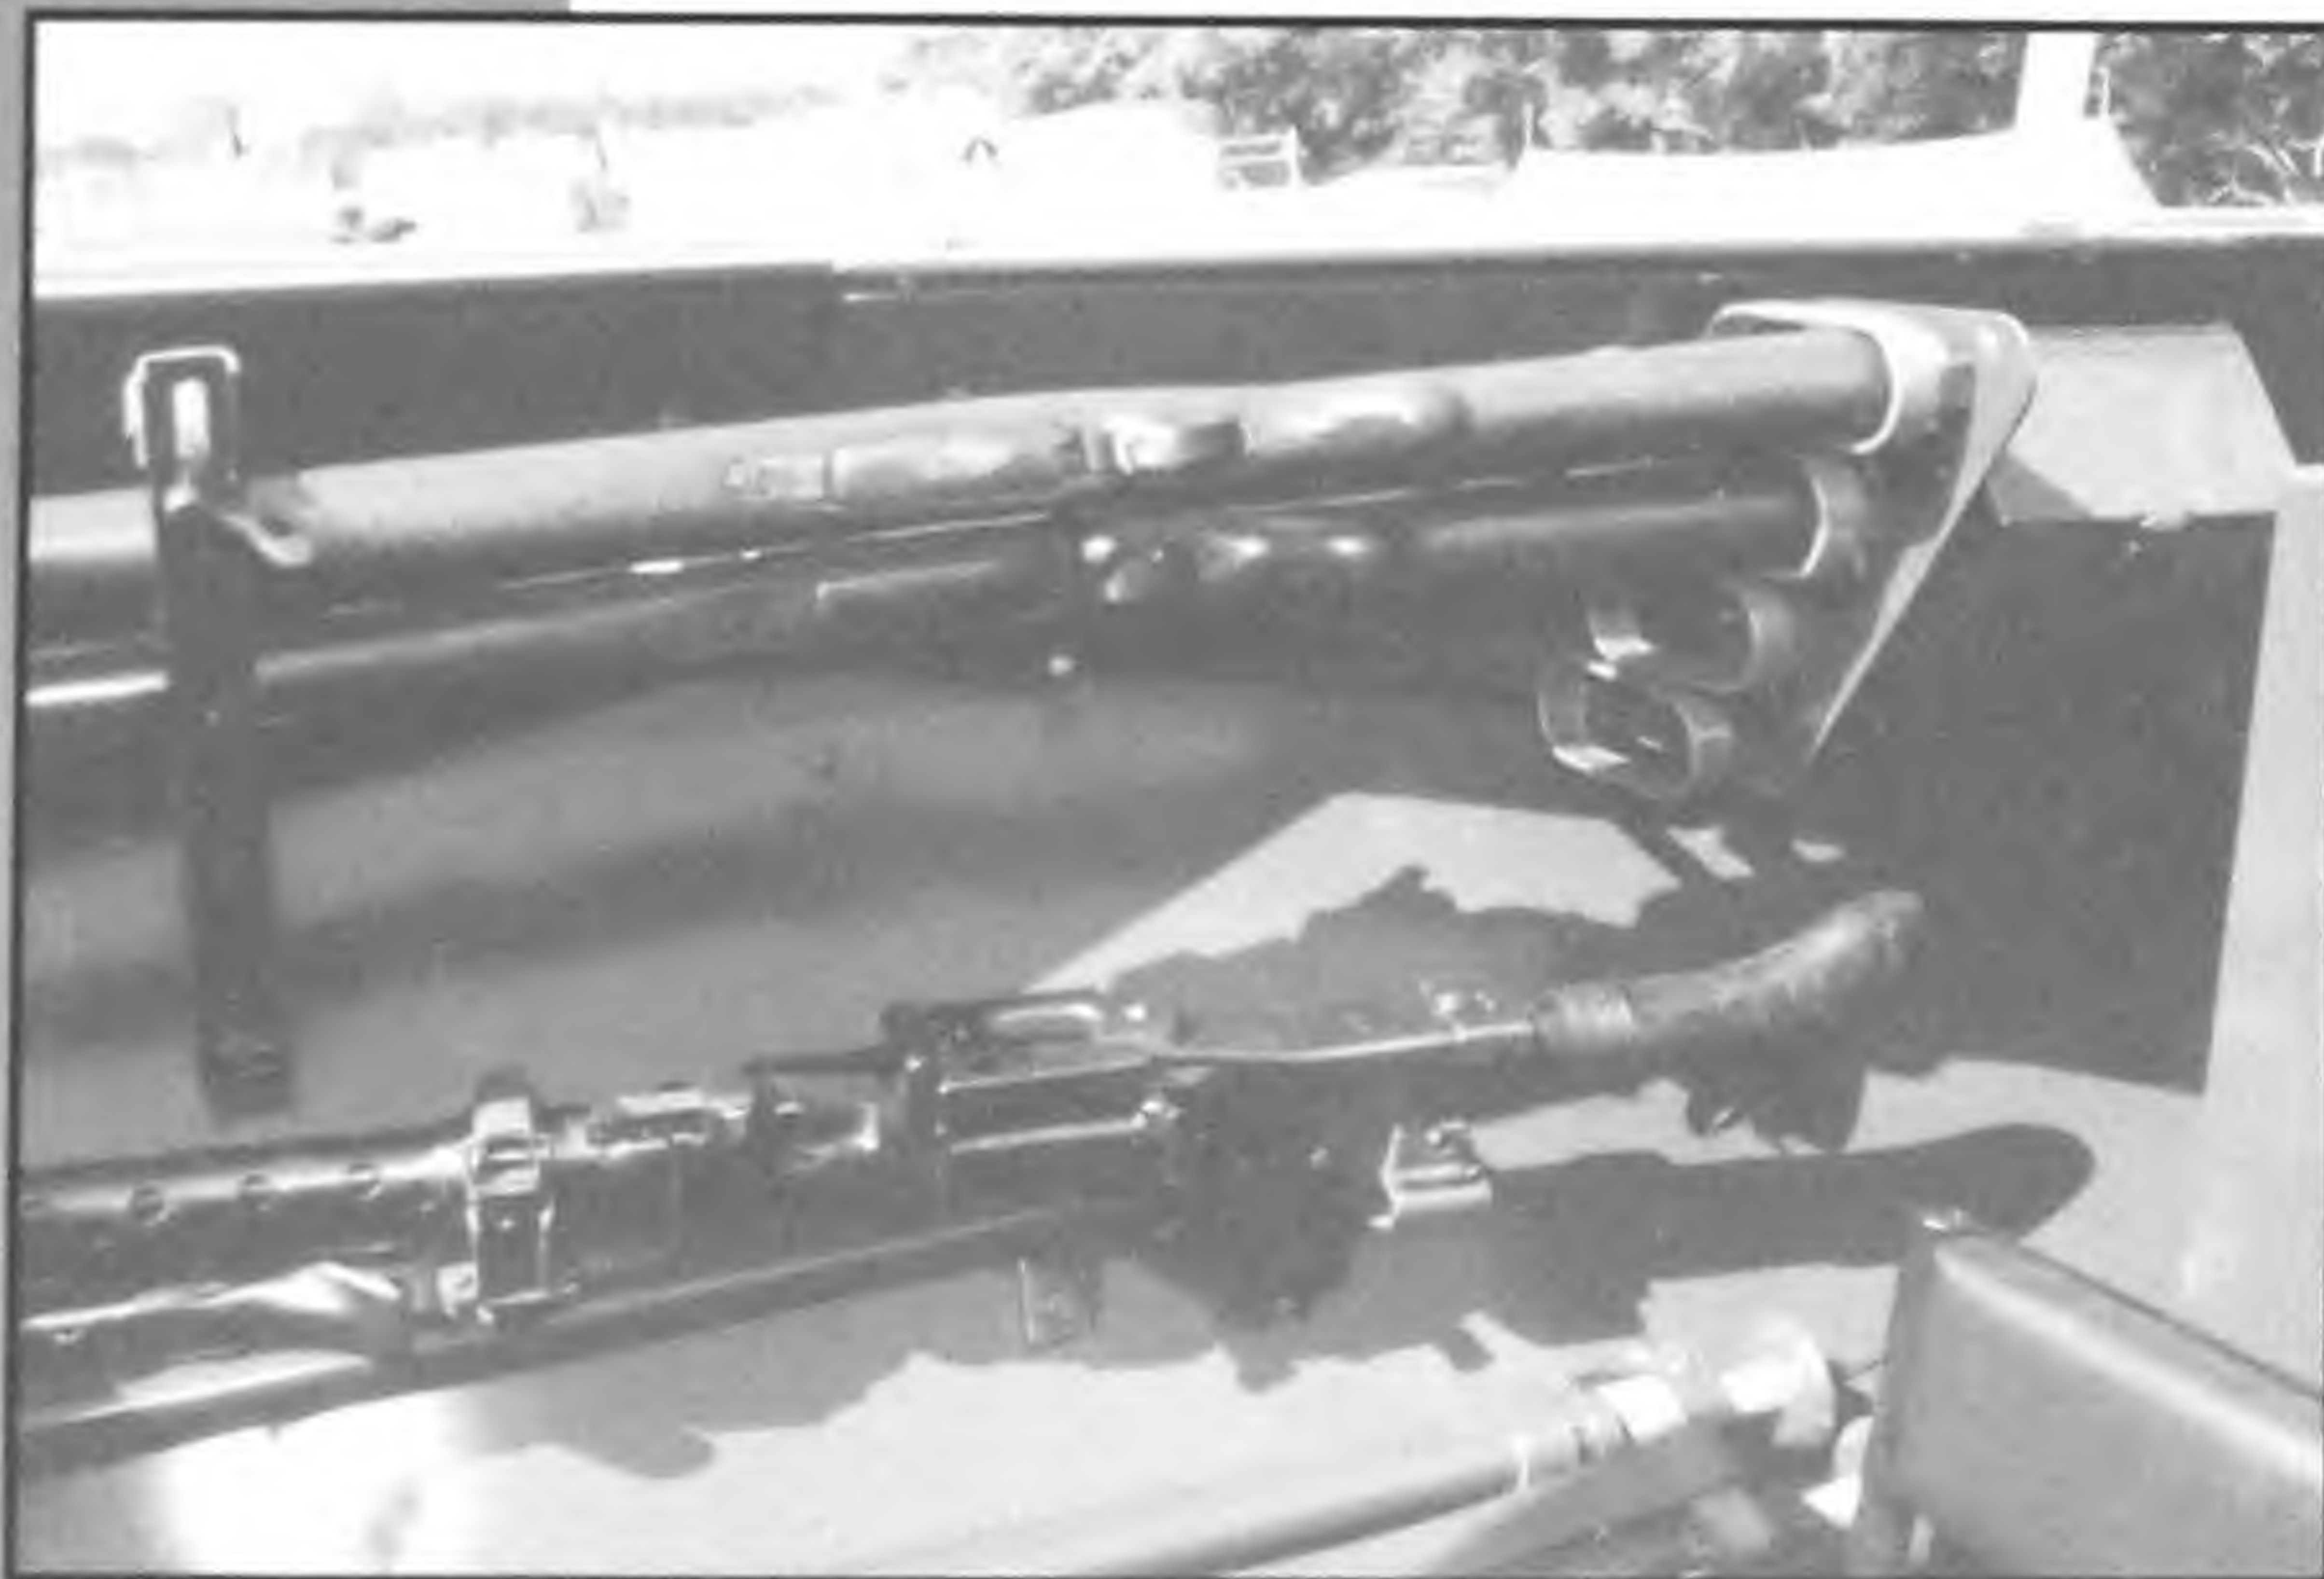
**Top left:** The Tetra "Feurloscher" fire extinguisher and its attendant brackets installed just inside the rear door. Two 50-round MG cartridges were stowed next to it. **Top right:** Just inside the rear door and looking back, the interior stowage locker can be seen, as well as the filler cap for the fuel tank. **Above left:**

On the right inside of the superstructure, there is stowage for a rifle for each of the four support "Halbgruppe" and a MG 34 or 42. The tripod for the machine gun can be seen just below. **Above right:** The area above the driver's head, showing details of the visors and the head pad.
